(NASA-CR-134527) PUMPED LITHIUM LOOP
TEST TO EVALUATE ADVANCED REFRACTORY
METAL ALLOYS AND SIMULATED NUCLEAR FUEL
ELEMENTS (General Electric Co.) 106 p
HC \$5.25

PUMPED LITHIUM LOOP TEST TO EVALUATE ADVANCED
REFRACTORY METAL ALLOYS AND SIMULATED NUCLEAR
TEST ELEMENTS

by G. P. Brandenburg, E. E. Hoffman, and J. P. Smith

GENERAL ELECTRIC COMPANY
Evandale, Ohio

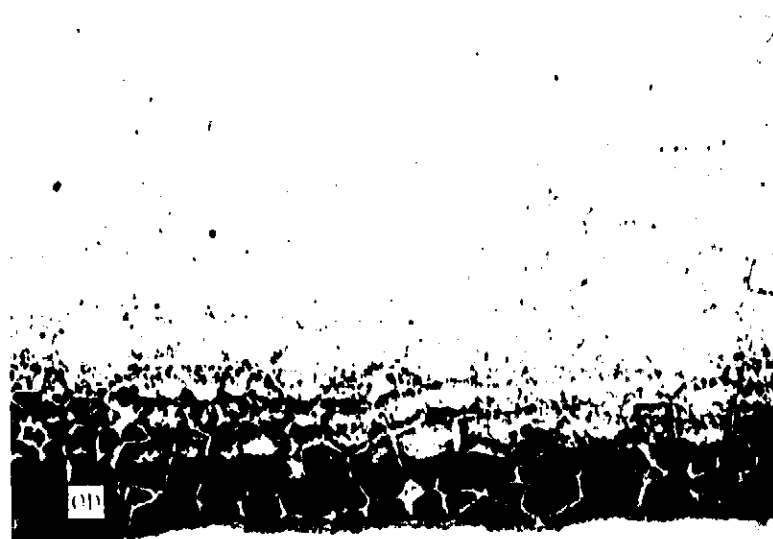
Figure 33. - Longitudinal microstructure of T-111 alloy corrosion specimen housing tubing in region of Li-Ar interface following 7500 hours exposure to essentially stagnant lithium in the 1040° C (1900° F) pumped lithium test loop. 250X
